Flood Control Project Maintenance
2009 Structure Summary Report
Overall Unit and Item Ratings

Lower San Joaquin Levee District

Flood Control Project Maintenance
Unit Cover Sheet
2009 Structure Inspection Results

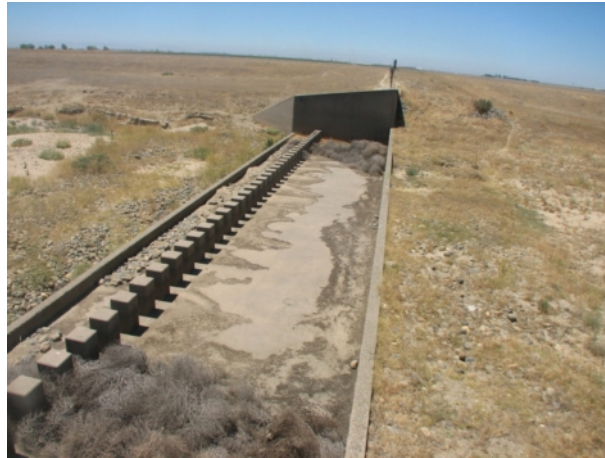
richard_20090804_81.jpg

Looking at overview of structure for the left bank.

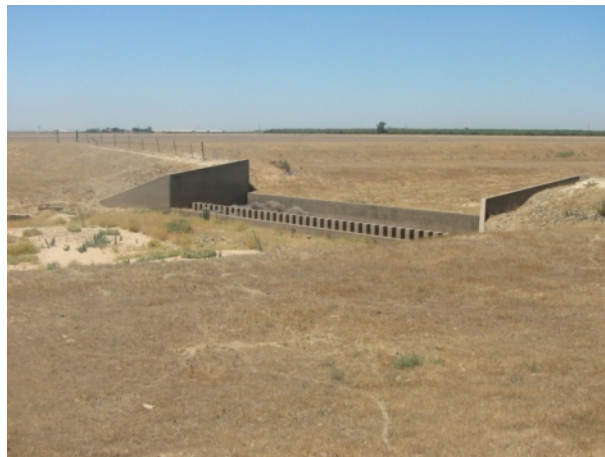
richard_20090804_82.jpg

Looking at overview of downstream side of the structure from the left bank.

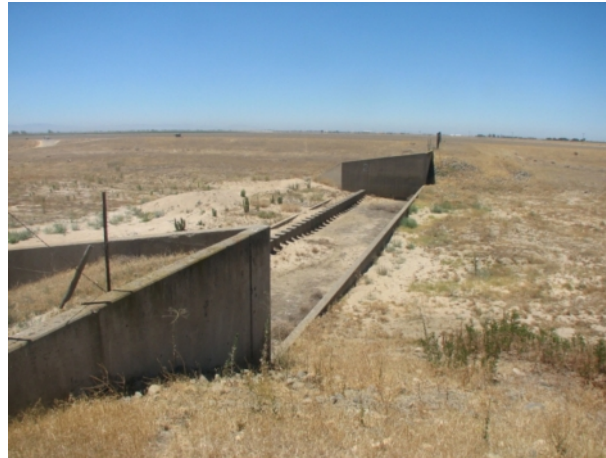
Levee Mile Report Line	1
Start Levee Mile	
End Levee Mile	
Location	
Category	Structures
Item	Photo Documentation
Looking at overview downstream side of structure from the left bank	
richard_20090804_79.jpg

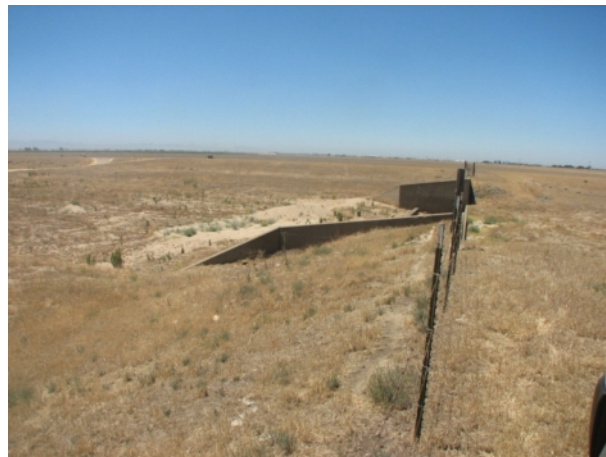
Levee Mile Report Line	1
Start Levee Mile	
End Levee Mile	
Location	
Category	Structures
Item	Photo Documentation
Looking at overview of structure for the left bank	
richard_20090804_80.jpg

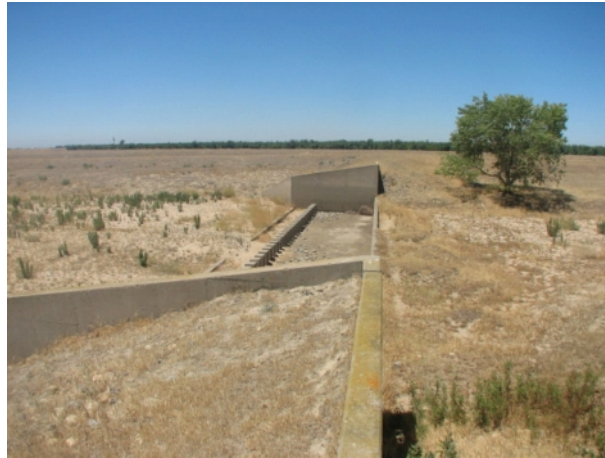
richard_20090804_77.jpg

Looking at overview of structure from the left bank.

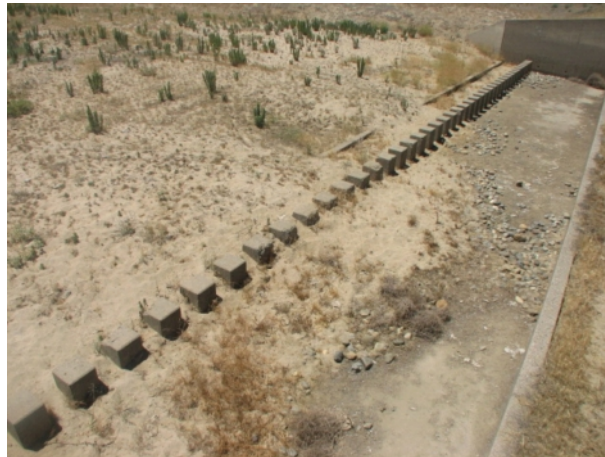
richard_20090804_78.jpg

Looking at downstream side of structure from the left bank.

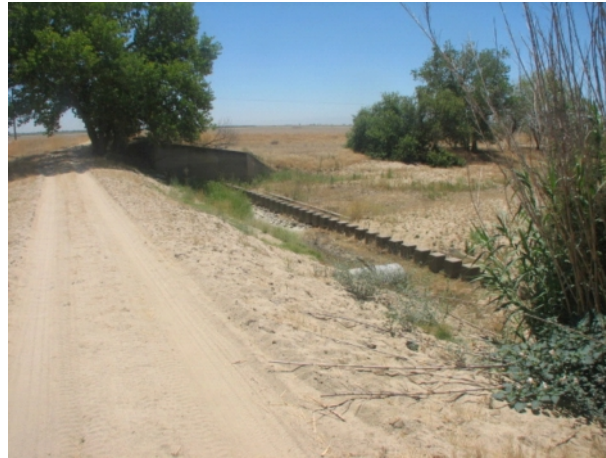
richard_20090804_75.jpg

Looking at overview of structure downstream side.

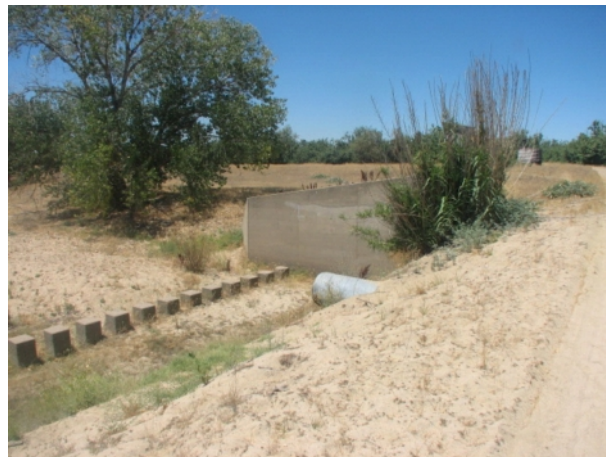
richard_20090804_76.jpg

Looking at upstream side of structure.

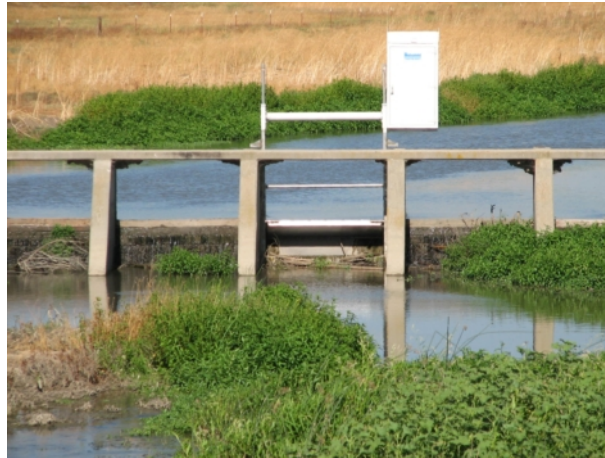
Levee Mile Report Line	5
Start Levee Mile	
End Levee Mile	
Location	
Category	Structures
Item	Electric Gate Operators
A Automatic Tide Flow Gate on upstream side of the structure	
richard_20090708_13.JPG

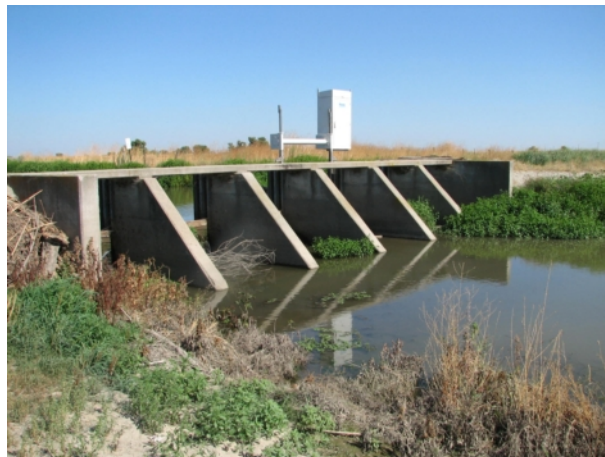
Levee Mile Report Line	7
Start Levee Mile	
End Levee Mile	
Location	
Category	Structures
Item	Concrete Foundations
Looking at the downstream side of the structure.	
richard_20090708_9.JPG

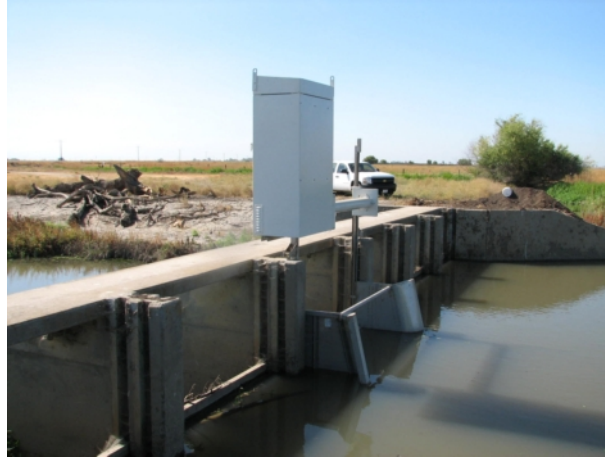
Levee Mile Report Line	7
Start Levee Mile	
End Levee Mile	
Location	
Category	Structures
Item	Concrete Foundations
Looking at the automatic tide flow gate on the upstream side of the structure	
richard_20090708_10.JPG

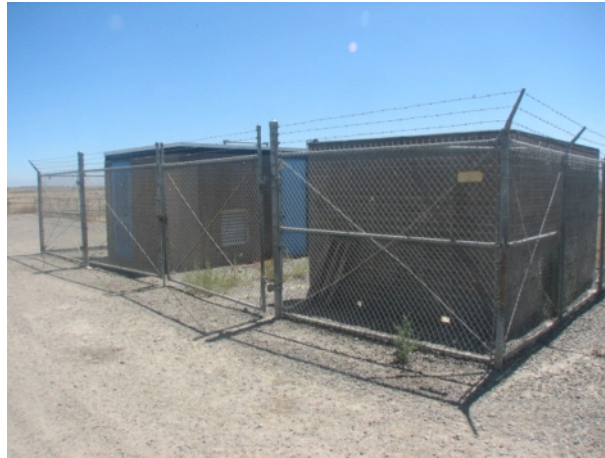
richard_20090803_64.jpg

Looking at overview of plant building

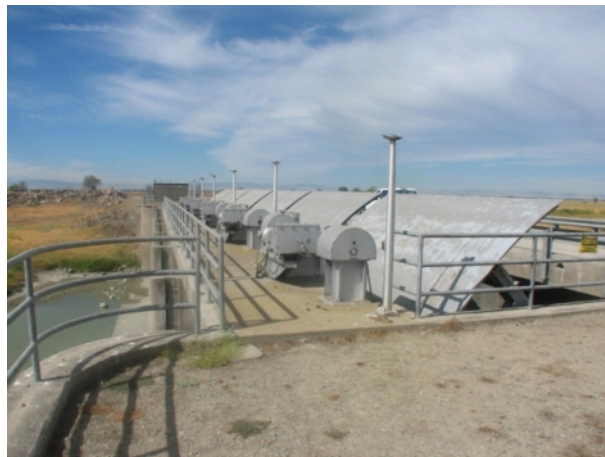
richard_20090708_16.jpg

Looking at motors and gates on the upstream side of the structure

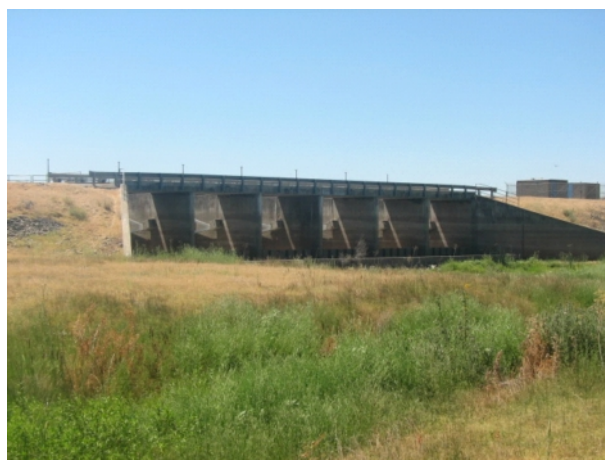
richard_20090803_62.jpg

Looking at overview of structure on the downstream side

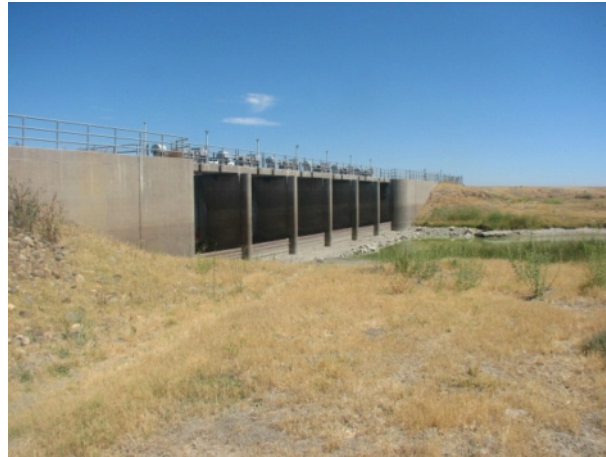
Levee Mile Report Line	3
Start Levee Mile	
End Levee Mile	
Location	
Category	Structures
Item	Photo Documentation
Looking at overview of structure on the upstream side	
richard_20090803_63.jpg

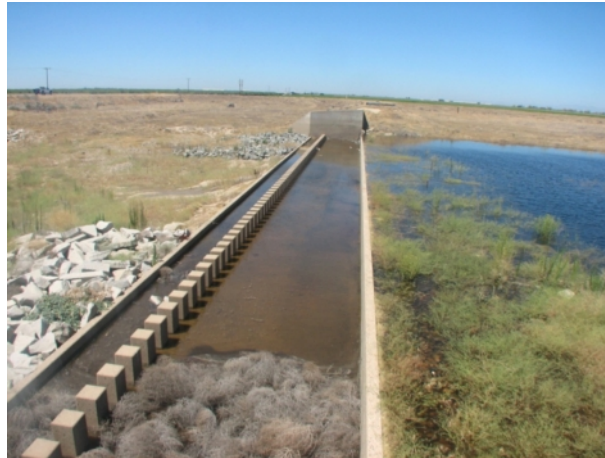
richard_20090804_89.jpg

Looking at overview of structure from the left bank.

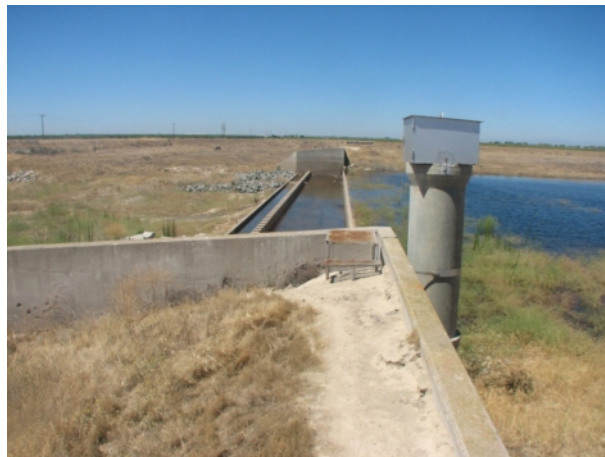
richard_20090804_90.jpg

Looking at overview of structure and guage station from the left bank.

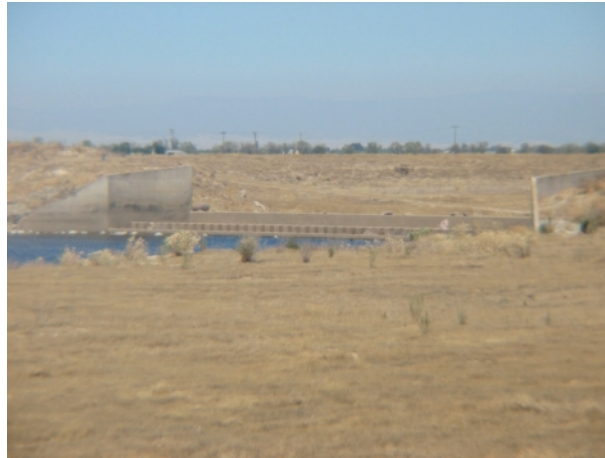
Levee Mile Report Line	1
Start Levee Mile	
End Levee Mile	
Location	
Category	Structures
Item	Photo Documentation
Looking at overview of downstream side from the left bank.	
richard_20090804_86.jpg

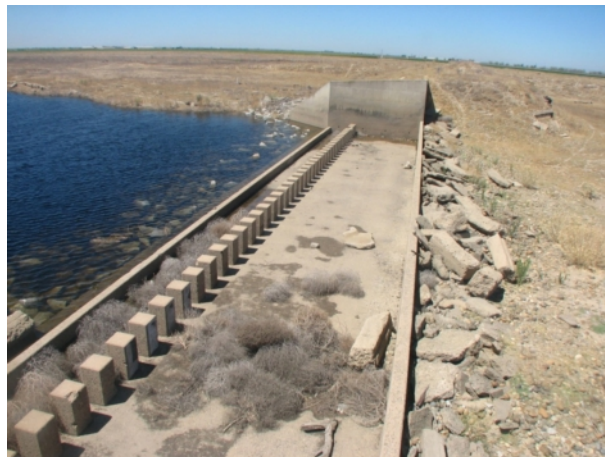
Levee Mile Report Line	1
Start Levee Mile	
End Levee Mile	
Location	
Category	Structures
Item	Photo Documentation
Looking at overview of structure from the left bank.	
richard_20090804_87.jpg

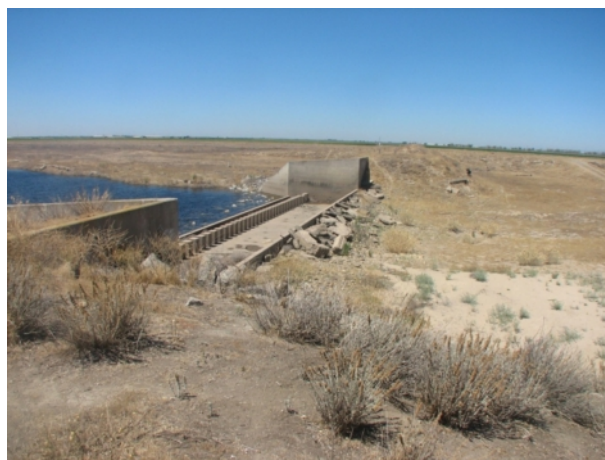
Levee Mile Report Line	1
Start Levee Mile	
End Levee Mile	
Location	
Category	Structures
Item	Photo Documentation
Looking at upstream side of structure from the left bank.	
richard_20090804_88.jpg

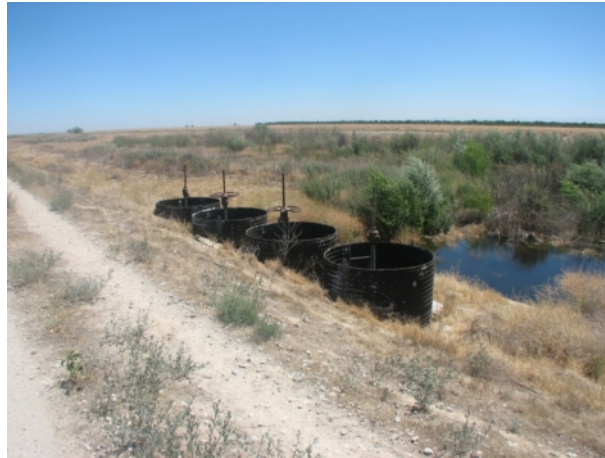
Levee Mile Report Line	1
Start Levee Mile	
End Levee Mile	
Location	
Category	Structures
Item	Photo Documentation
Looking at screw gates	
richard_20090804_83.jpg

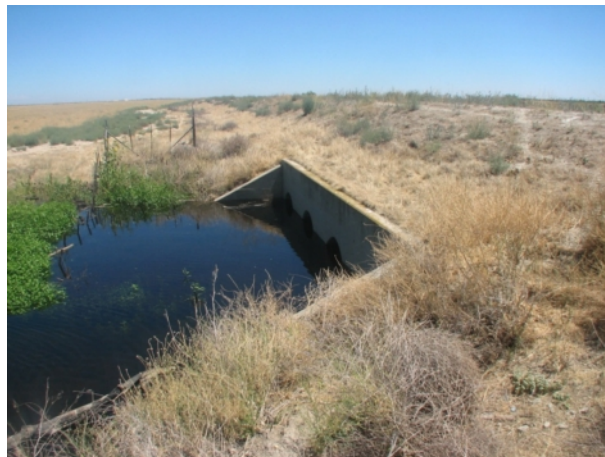
Levee Mile Report Line	1
Start Levee Mile	
End Levee Mile	
Location	
Category	Structures
Item	Photo Documentation
Looking at overview of inlet side of structure	
richard_20090804_84.jpg

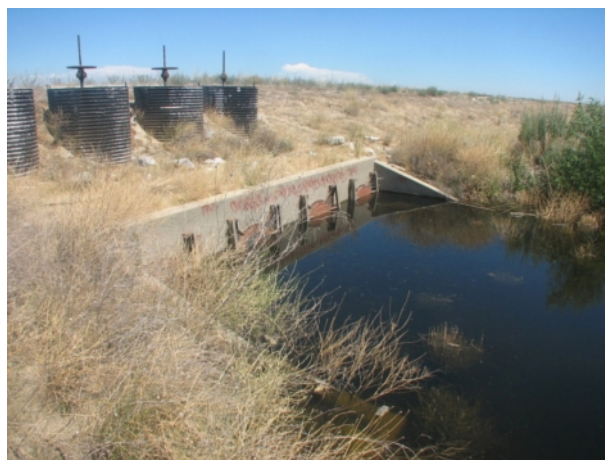
Levee Mile Report Line	1
Start Levee Mile	
End Levee Mile	
Location	
Category	Structures
Item	Photo Documentation
Looking at overview of outlet side of structure	
richard_20090804_85.jpg

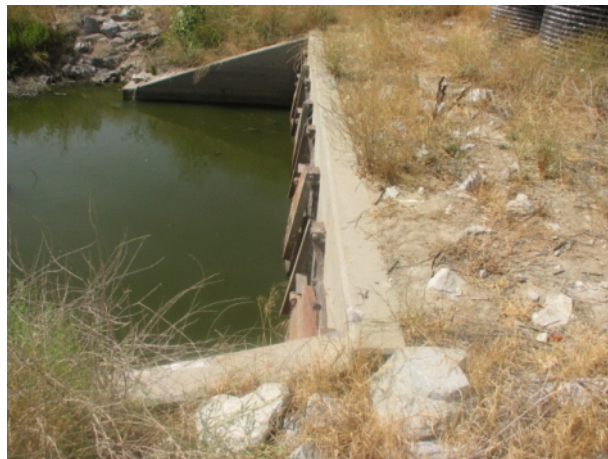
Levee Mile Report Line	6
Start Levee Mile	
End Levee Mile	
Location	
Category	Structures
Item	Flap Gates
Looking at flap gates in good operating conditions.	
richard_20090708_21.jpg

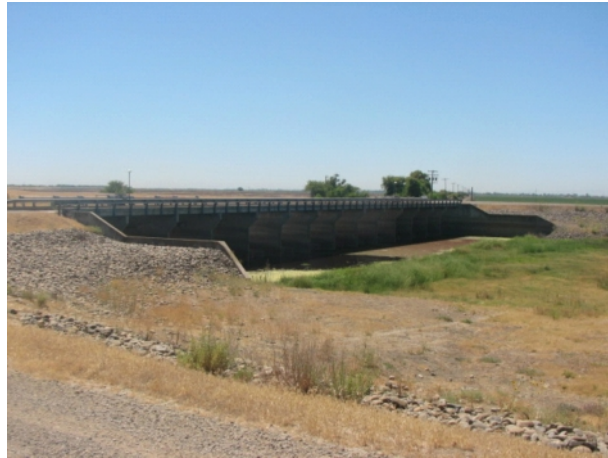
Levee Mile Report Line	2
Start Levee Mile	
End Levee Mile	
Location	
Category	Structures
Item	Photo Documentation
Looking at overview of downstream side of structure.	
richard_20090803_67.jpg

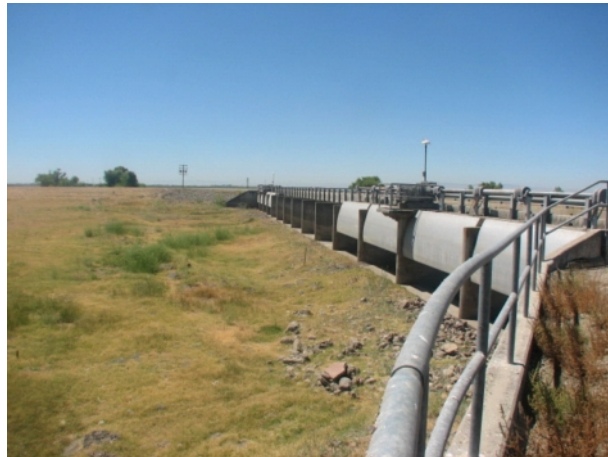
Levee Mile Report Line	2
Start Levee Mile	
End Levee Mile	
Location	
Category	Structures
Item	Photo Documentation
Looking at overview of upstream side of structure.	
richard_20090803_68.jpg

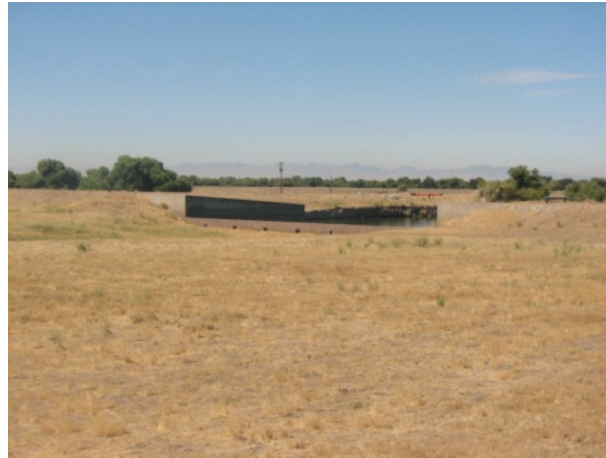
Levee Mile Report Line	1
Start Levee Mile	
End Levee Mile	
Location	
Category	Structures
Item	Photo Documentation
Looking at overview of structure on upstream side.	
richard_20090803_58.jpg

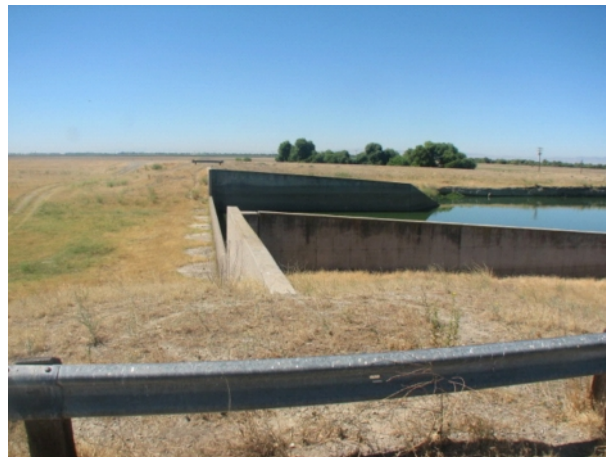
Levee Mile Report Line	1
Start Levee Mile	
End Levee Mile	
Location	
Category	Structures
Item	Photo Documentation
Looking south at overview of structure.	
richard_20090803_59.jpg

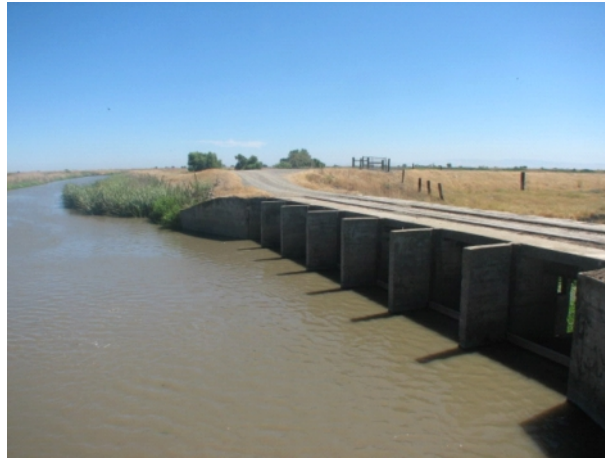
Levee Mile Report Line	1
Start Levee Mile	
End Levee Mile	
Location	
Category	Structures
Item	Photo Documentation
Overview of the upstream side of structure.	
richard_20090803_57.jpg

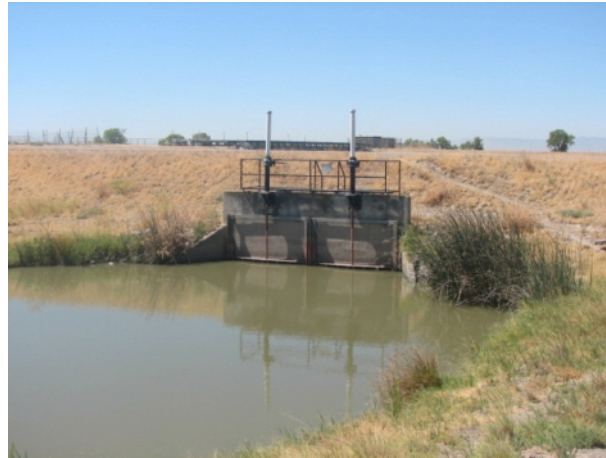
Levee Mile Report Line	1
Start Levee Mile	
End Levee Mile	
Location	
Category	Structures
Item	Photo Documentation
Looking at overview of structure on upstream side (control gates) of the structure	
richard_20090803_61.jpg

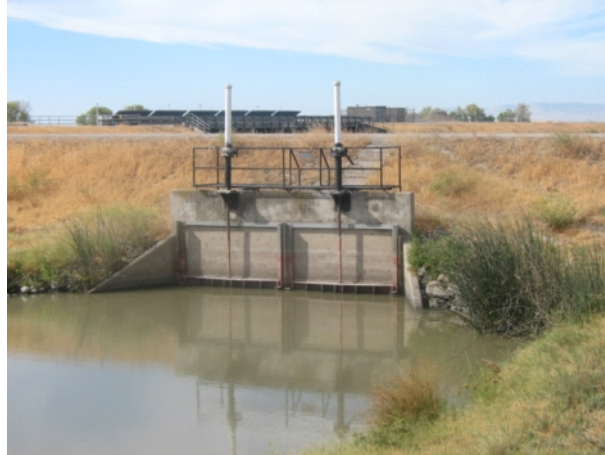
Levee Mile Report Line	4
Start Levee Mile	
End Levee Mile	
Location	
Category	Structures
Item	Culverts: Inlets / Outlets
View of the two 72 inch slide gates on the inlet side of the structure in good working condition.	
richard_20090708_36.jpg

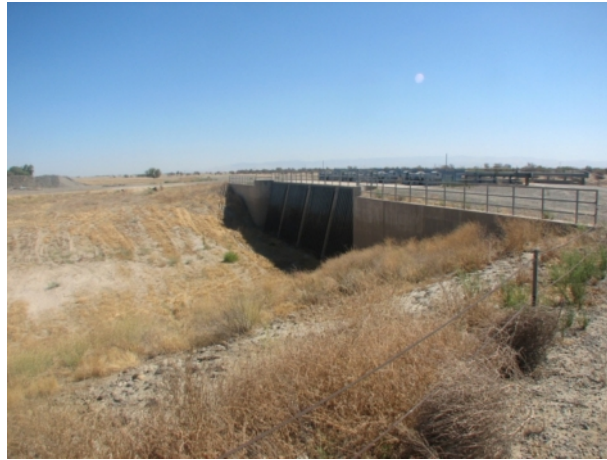
Levee Mile Report Line	2
Start Levee Mile	
End Levee Mile	
Location	
Category	Structures
Item	Photo Documentation
Looking at overview of upstream side of structure	
richard_20090805_92.jpg

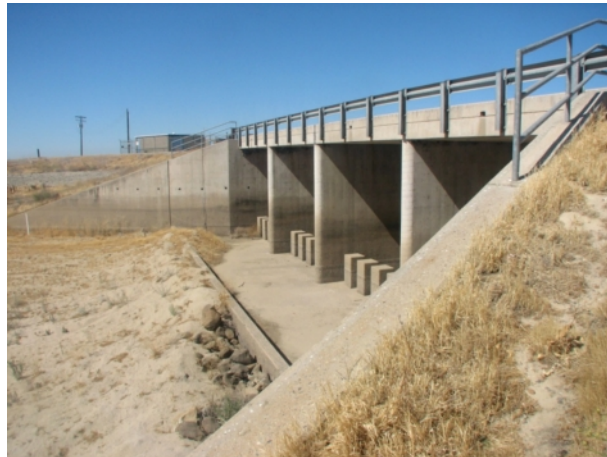
Levee Mile Report Line	2
Start Levee Mile	
End Levee Mile	
Location	
Category	Structures
Item	Photo Documentation
Looking at overview of downstream side of structure	
richard_20090805_93.jpg

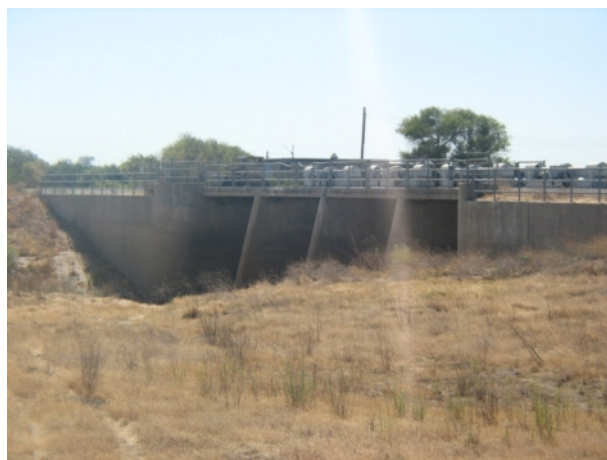
Levee Mile Report Line	3
Start Levee Mile	
End Levee Mile	
Location	
Category	Structures
Item	Photo Documentation
Looking at overview of upstream side of structure	
richard_20090805_94.jpg

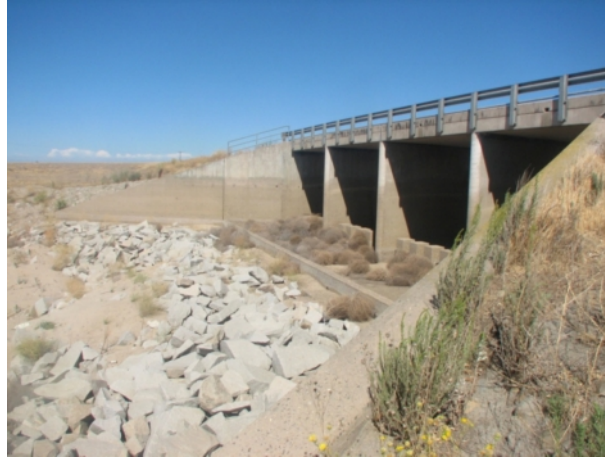
Levee Mile Report Line	3
Start Levee Mile	
End Levee Mile	
Location	
Category	Structures
Item	Photo Documentation
Looking at overview of downstream side of structure.	
richard_20090805_95.jpg

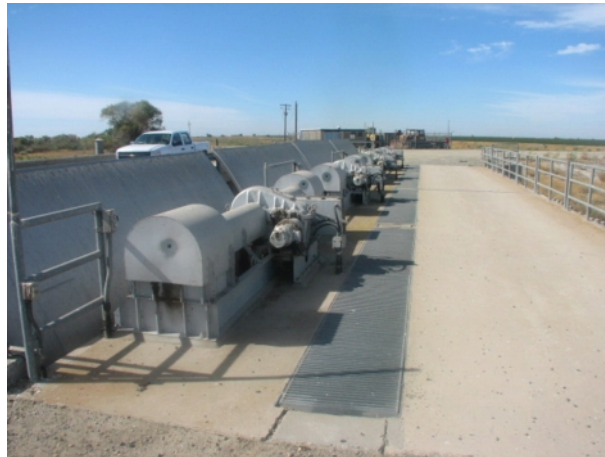
Levee Mile Report Line	6
Start Levee Mile	
End Levee Mile	
Location	
Category	Structures
Item	Vegetation & Obstructions
Looking at motors and gates on the downstream of the structure.	
richard_20090708_40.jpg

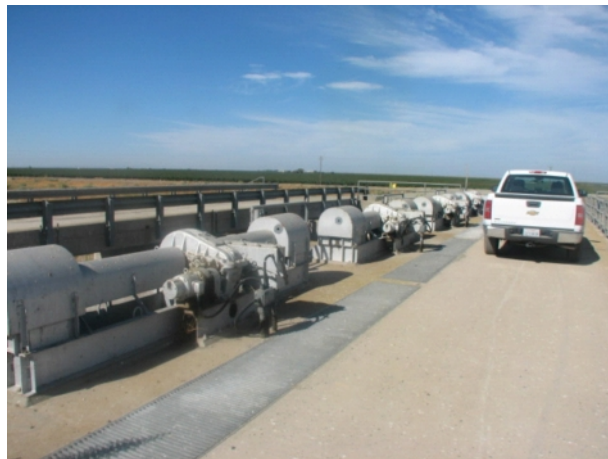
Levee Mile Report Line	12
Start Levee Mile	
End Levee Mile	
Location	
Category	Structures
Item	Electric Gate Operators
Looking at electric gates and motors.	
richard_20090708_43.jpg

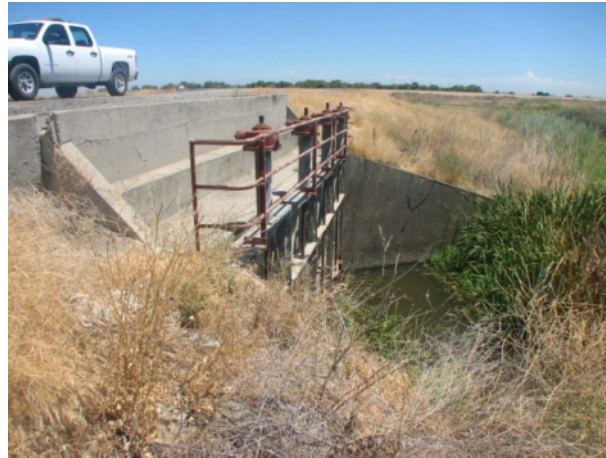
Levee Mile Report Line	1
Start Levee Mile	
End Levee Mile	
Location	
Category	Structures
Item	Photo Documentation
Looking south at overview of structure (Screw gates)	
richard_20090803_71.jpg

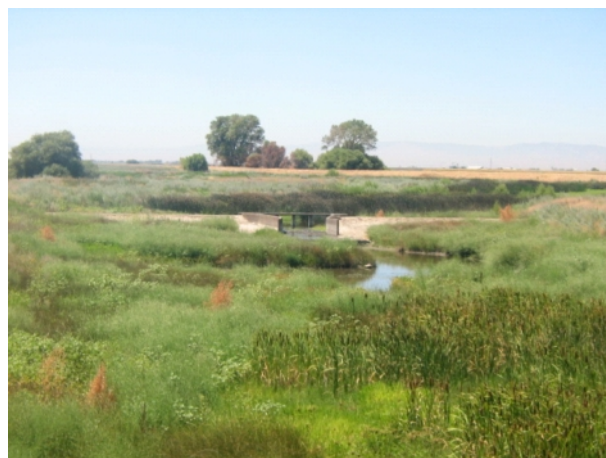
Levee Mile Report Line	2
Start Levee Mile	
End Levee Mile	
Location	
Category	Structures
Item	Photo Documentation
Looking at overview of structure for Washington Road Bridge (north)	
richard_20090803_69.jpg

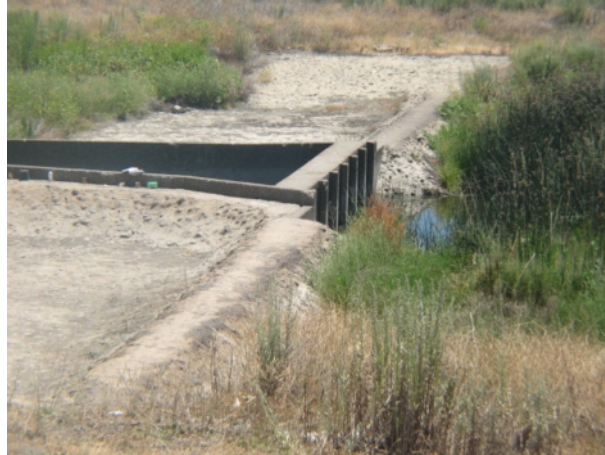
Levee Mile Report Line	2
Start Levee Mile	
End Levee Mile	
Location	
Category	Structures
Item	Photo Documentation
Looking at overview of structure from the right bank.	
richard_20090803_70.jpg

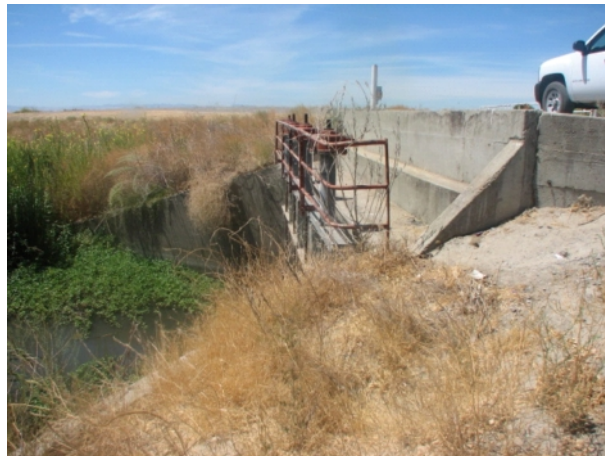
Levee Mile Report Line	8
Start Levee Mile	
End Levee Mile	
Location	
Category	Structures
Item	Manual Gate Operators
Looking at the manual gates on the outlet side of the structure.	
richard_20090708_47.jpg
